**Document ID: 4167626**

## #15069: Service Update for Inventory and Customer Vehicles - C-Pillar Baffle Noise - Expires with Base Warranty - (Apr 21, 2015)

**Models: 2015 Chevrolet Colorado  
2015 GMC Canyon**

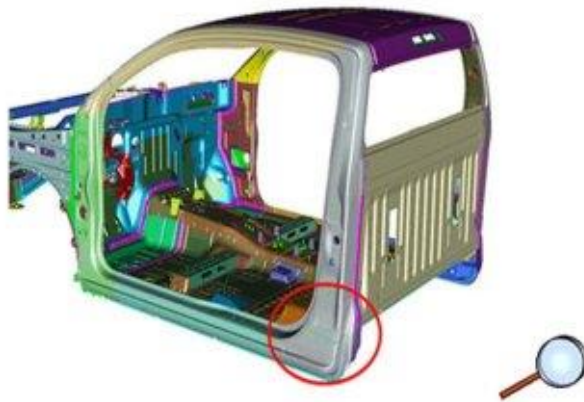
**Note:** Inspect for the existence of a baffle, positioned between the inner and outer C-pillar sheet metal during the body shop production process. Though not visible from the exterior, its left side location is shown circled above.

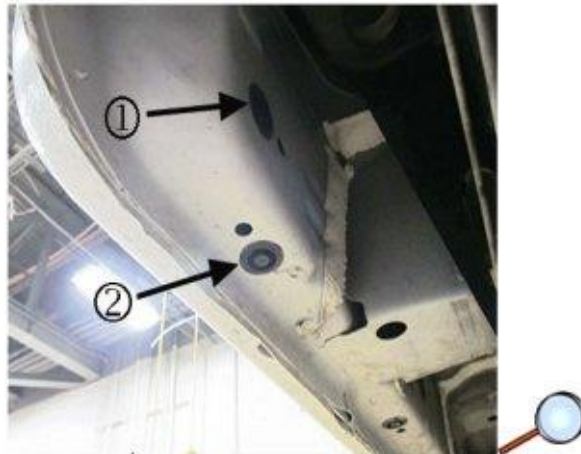
2. Locate the body plug (2) in the rear, C-pillar area of the rocker panel. There is one plug located on each side of the truck.
3. Remove that body plug and a second plug (1) in the vertical portion of the rocker, just above the first plug.

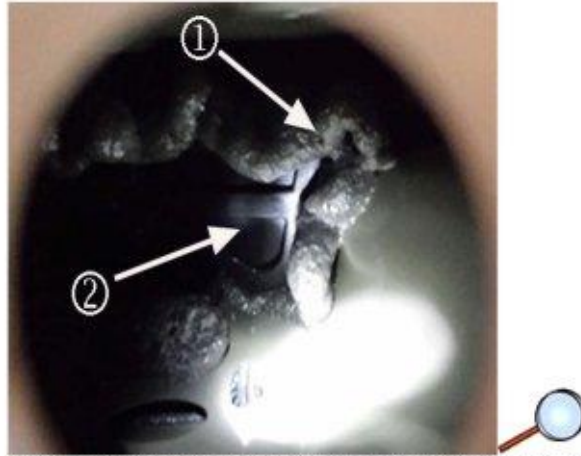
4. Shining a flashlight in the vertical hole, look upward from the bottom hole and inspect the inner rocker for the existence of foam (1) and baffle (2).
5. Repeat steps 3 and 4 on the opposite side rocker panel.
6. Upon inspection of both rocker panels:
  - If there is visual evidence of the foam/baffle in BOTH locations, no further action is required. Reinstall all body plugs and lower the vehicle.
  - If there is NO visual evidence of the foam/baffle in one or either location, reinstall all body plugs, lower the vehicle and continue ahead to the *Expandable Foam Installation Procedure*.

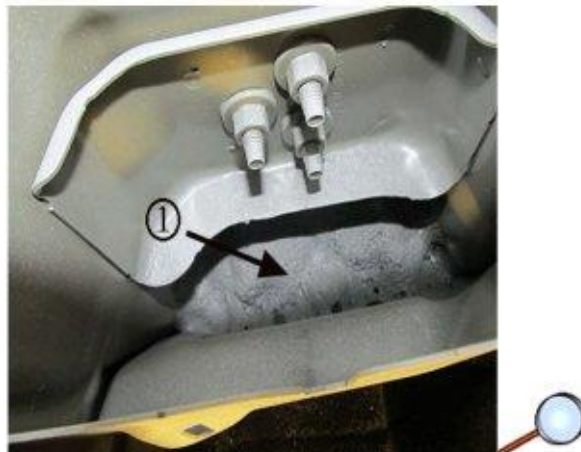
**Note:** The graphic above shows the top side foam (1) on a **factory installed baffle**. The new single layer of expandable foam should be applied at approximately the same height below the bracket shown.

2. Access the open pocket in the inner sheet metal.
