2010 Chevy Cobalt

#15075: Product Safety - Side Impact Sensor (SIS) Wire Chafe at Window Regulator - (Aug 5, 2015)

Subject: 15075 – Side Impact Sensor (SIS) Wire Chafe at Window Regulator

Models: 2010 Chevrolet Cobalt 4-Door Sedan

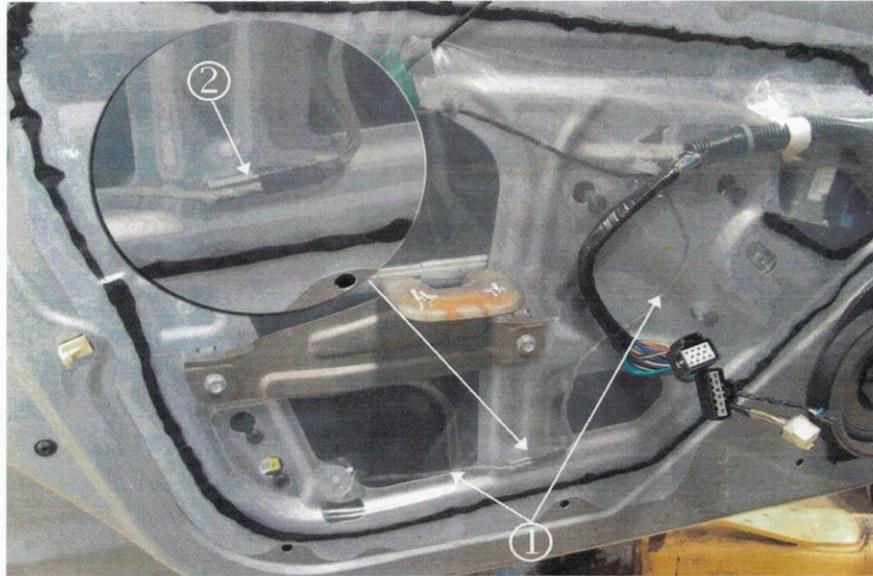
2. Locate the side impact sensor (SIS) wire harness (1).
 3. Determine if the SIS wire harness clip is in the horizontal or vertical position.
 - If the SIS wire harness clip is positioned in the horizontal position (2), cycle the window to ensure that the SIS wire does NOT contact the window regulator.
 - If the SIS wire harness does NOT contact the window regulator, no further action is required. Re-install the front driver side door trim panel. Refer to *Front Side Door Trim Panel Replacement* in SI.
 - If the SIS wire harness does contact the window regulator, proceed to step 4.

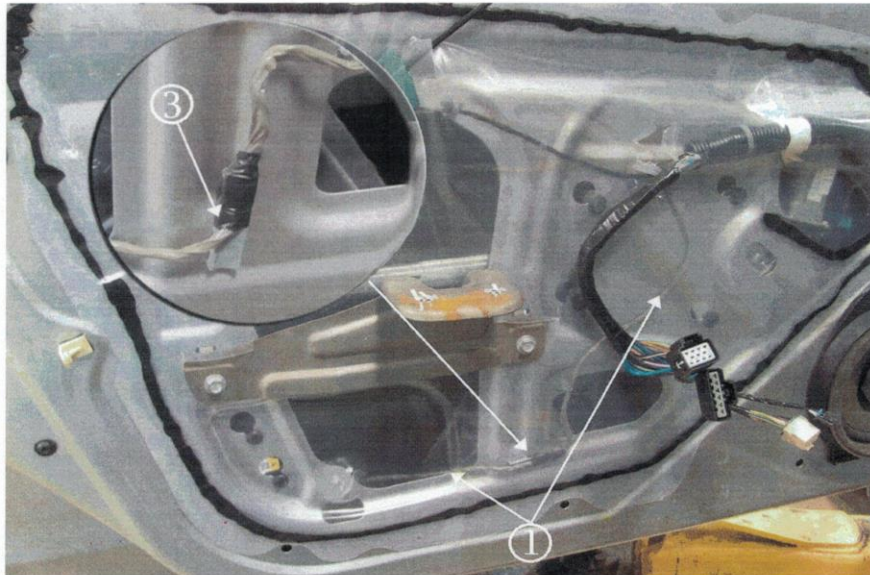
- If the SIS wire harness clip is positioned in the vertical position (3), partially remove the vapor barrier to gain access to the SIS wiring harness and clip. Remove the pull cup bracket to partially remove the vapor barrier. Proceed to step 4.
