**BMW 2 Series Coupe 2015**

**Technical Service Bulletin: S1 B51 33 15**

**Service Action: Repair the PVC seam on the left A-pillar**

F22 (2 Series Coupe)

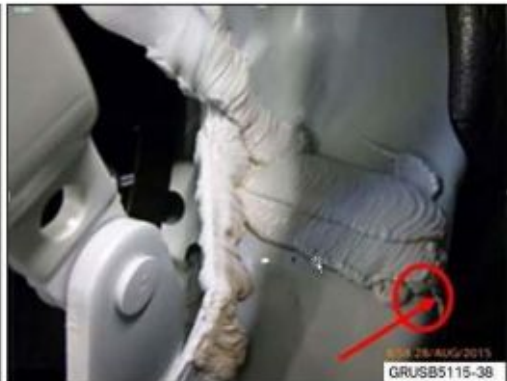
The joint of the bulkhead plate and A-pillar reinforcement is supposed to be sealed with an adhesive strip and a PVC seam. The PVC seam was not applied correctly in places and can cause leaks.

2. **Clean the affected surface and increase the length of the existing PVC seam in the direction of the side panel (see arrow).**

- Note: Push sealant into the gap and smooth out the seam.
