#15797: Customer Satisfaction - Trunk Water Leak at Right Side Tail Lamp - (Nov 9, 2015)

Subject: 15797 – Trunk Water Leak at Right Side Tail Lamp

Models: 2016 Chevrolet Cruze

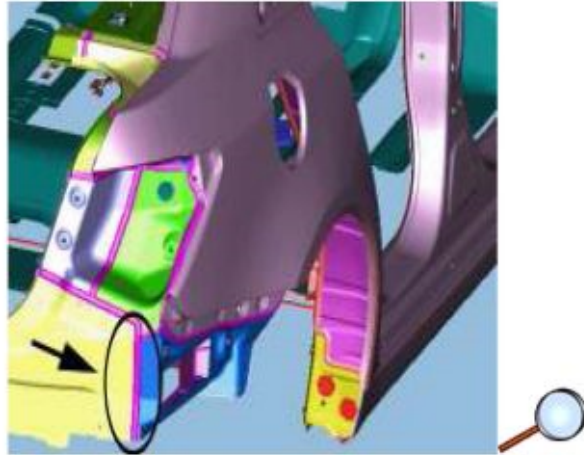
Note: Fascia does not need to be removed for repair. Picture above is for reference.

1. Raise the vehicle.
2. If required, clean any dirt or loose debris from the seam to be sealed.
3. Using a general purpose adhesive cleaner, clean the area to be sealed.
