**Document ID: 4167626**

## #15069: Service Update for Inventory and Customer Vehicles - C-Pillar Baffle Noise - Expires with Base Warranty - (Apr 21, 2015)

**Models: 2015 Chevrolet Colorado  
2015 GMC Canyon**

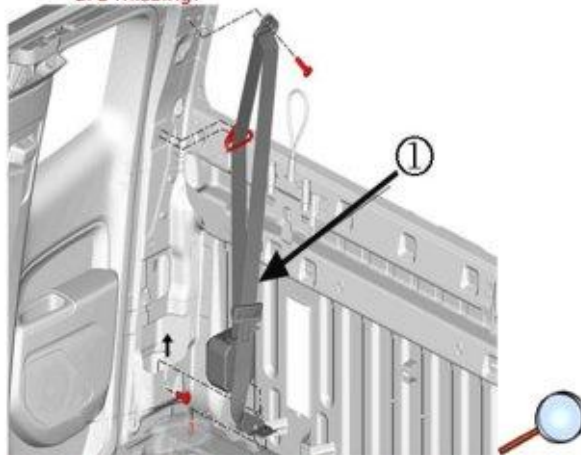
**Note:** Install expandable foam to the affected side missing the baffle, or to both sides, if both are missing.

**Note:** If baffles on both sides are missing, remove BOTH rear seat belt retractors as the preliminary steps prior to applying the expandable foam. To avoid the foam curing in the cartridge, the foam application must move immediately from one side to the other.

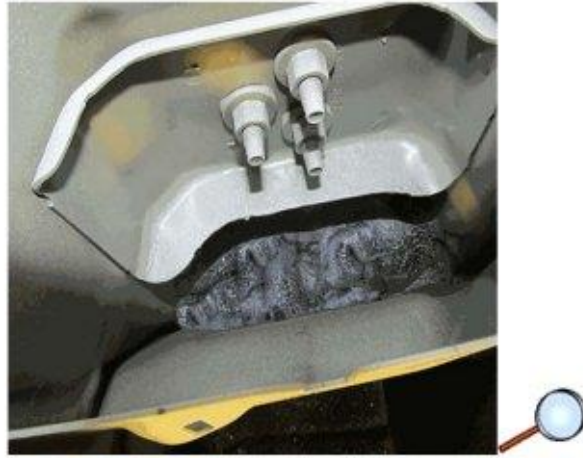
**Note:** The graphic above shows the top side foam (1) on a **factory installed baffle**. The new single layer of expandable foam should be applied at approximately the same height below the bracket shown.

**Note:** If the partially used cartridge is being stored for re-use, the mix tip **MUST BE REMOVED** immediately. If not removed, the foam will cure back into the cartridge and plug it; rendering it useless.

3. Install a layer of *3M™\* Flexible Foam, P/N 08463*, to completely close off the opening. Follow the Tip below to build the foam layer and minimize run down into the cavity.

**Tip:** You can control the way this foam applies by "Timing" how it is dispensed. Dispense the foam at a pace which allows the foam to kick off expansion, build upon itself and stay in position better. Starting along one of the outboard sheet metal walls, patiently apply a starting row of foam, then continue building rows inboard until the opening is sealed off. Follow the manufacturer's recommended drying time.
